THE TEMPLE

TRIPURESHWAR MAHADEV MANDIR

THE SATTAL

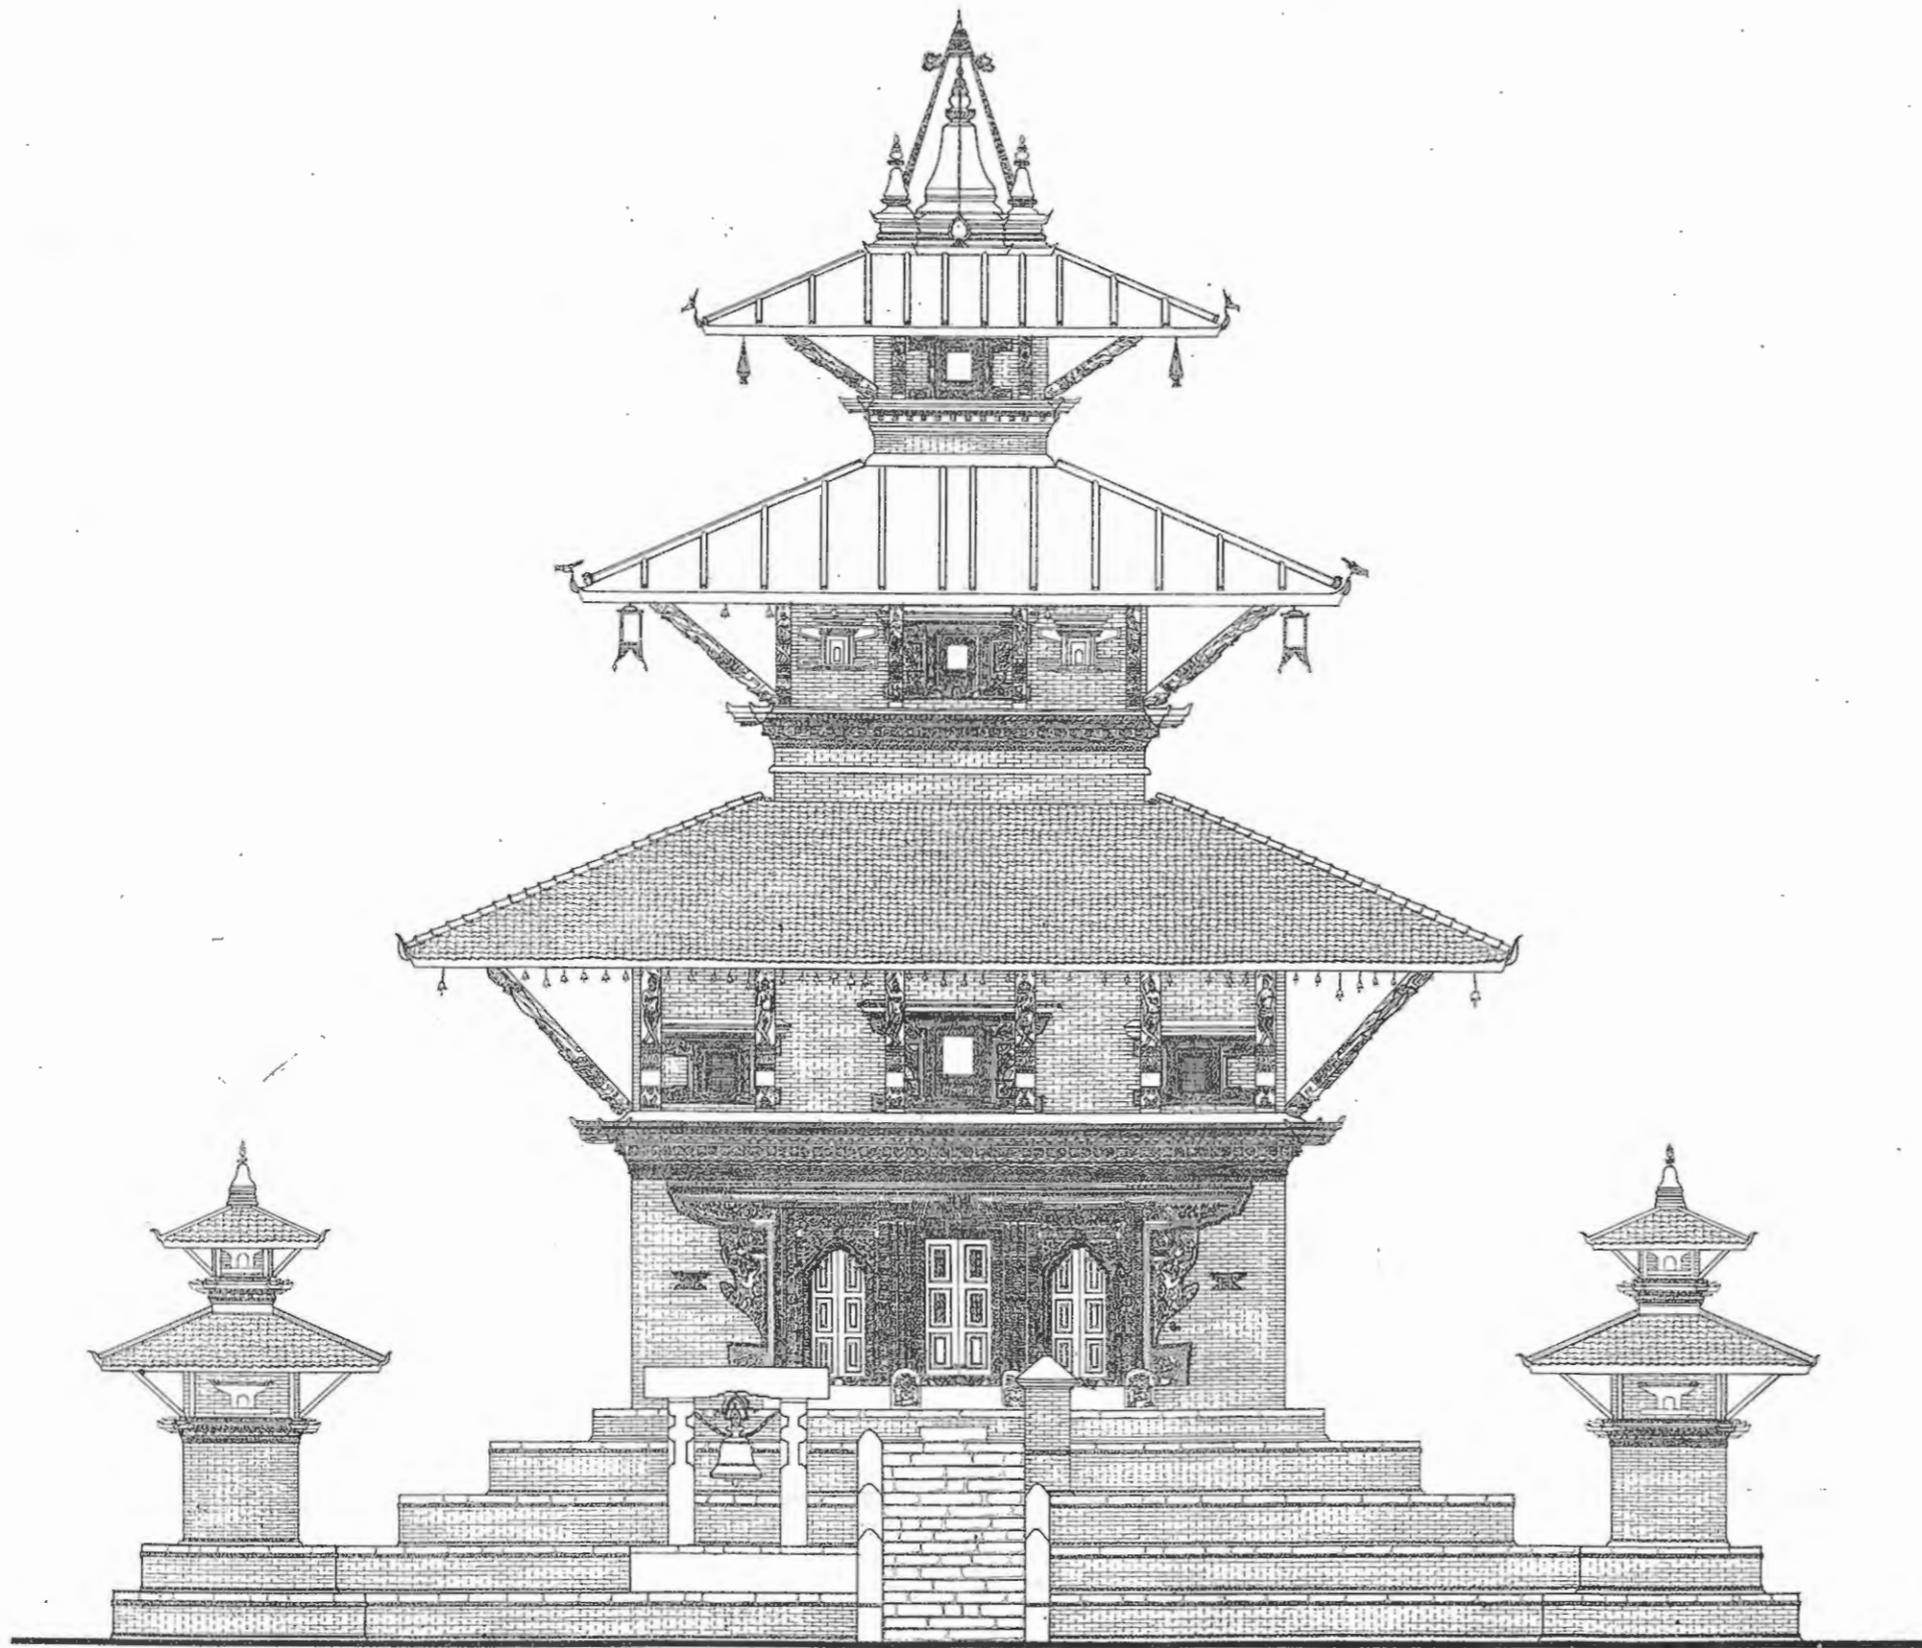
Fig. 36. South Elevation of Tripureswar Temple.

The roofs are of traditional timber construction supported off external walls and a central brick core which in turn carries the upper two roofs. The lower roof is covered with the traditional *Jhingati* tile set in a thick bed of clay, the upper two roofs are covered with copper sheeting (and originally gilded). The external walls of the temple structure are constructed with the special *do appa* (traditional wedge shaped bricks) that hide the mortar joints, several of which have been replaced with simple handmade bricks. The carved *Tunasi* to all the roofs and the 28 elaborately carved windows and four carved triple door are, except where damaged by water penetration, in reasonably good condition.

A complete and thorough structural survey of the temple is not possible without scaffolding. From initial investigations it seems that, in general, the upper two metal roof structures are in reasonable condition. However it is anticipated that many of the *musi* (rafters) will have rotted under the metal covering and will need to be replaced. It is recommended therefore to remove the roof covering, the *phalek* (timber boarding) and to check the condition of the timber rafters and their fixings. When the structural timbers, such as the supporting beams carrying the uppermost roof structure are exposed, they should also be thoroughly checked for structural integrity. It is likely that the boarding to both the roofs will require almost complete renewal.

The lowest roof covered with *jhingati* tiles is, through lack of maintenance requiring a total overhaul. It is recommended that the structural integrity of the wall plates is carefully checked and if necessary they should be replaced with a carefully designed concrete ring beam which can be hidden within the present structure. The old timbers should be treated against infestation in situ.

New timbers in all the roofs and other timber structural elements should be chemically treated against wood boring insects and fungal attacks. When replacing the clay bed for the tiles, the clay should be treated with a special herbicide to prevent the growth of vegetation and the tiles should be dipped in a silicone preparation to prevent undue rainwater absorption.

The brickwork requires some careful conservation and replacement. It is recommended that a careful assessment is made of the replacement requirements and new bricks are specially ordered from the kiln to replace them.

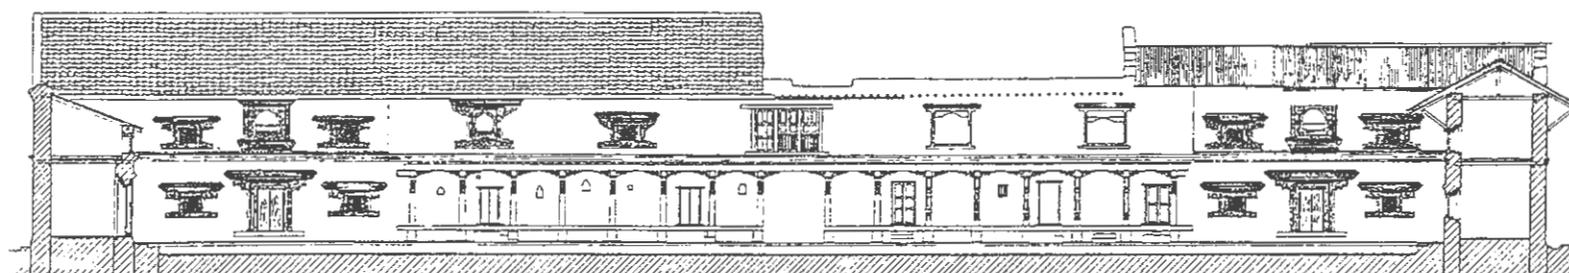
NORTH WING

The North elevation has remained largely intact following the 1934 earthquake and is perhaps the most complete example today of the design and style of the original structure. The 14 bay *pati* has been given over completely to living space. At least 75% of the original traditional roof structure of this wing remained intact until August 1993 at which time a fire destroyed a further 25%.

The central *paanch jyaal* (five bay carved window) and two smaller windows which previously dominated this facade have been replaced with three, more simple carved timber windows, (two of which were destroyed in the recent fire).

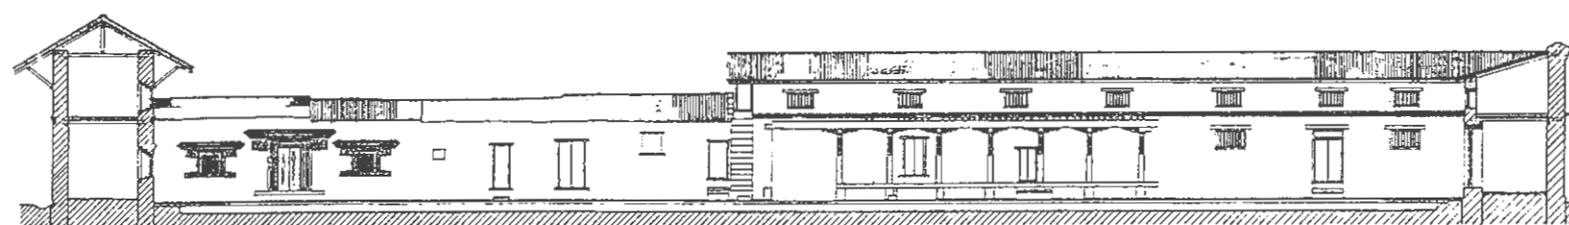
SOUTH WING

This wing was largely destroyed by the earthquake in 1934, leaving only one original door and two windows at the western end. A small section of adjoining *pati* has been partially rebuilt to provide half-height storage space on the upper level where religious objects connected with temple's rituals are stored. Both the *pati* and the ruined section have been commandeered for living space.

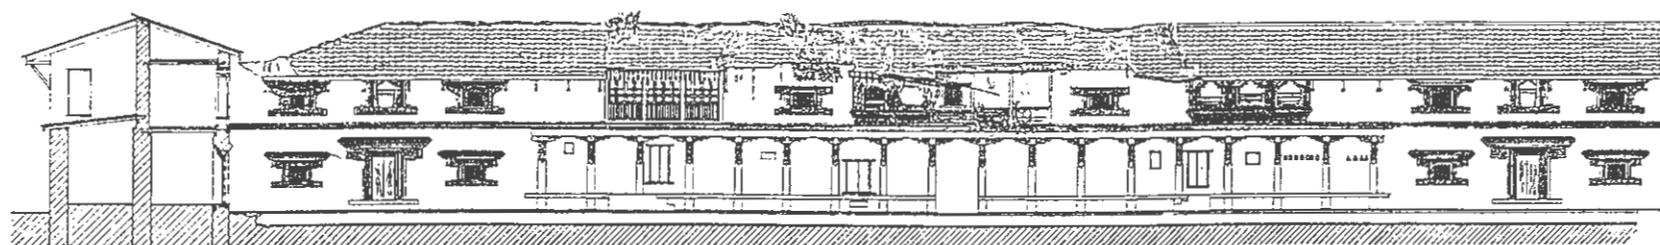
EAST WING

This wing is undoubtedly the most intact. While a large part of the existing roof is of the original design, it is in a severe state of dilapidation - whilst an attempt has been made to depict the present condition of these elevations the collapse of the central section has continued throughout the production of this report. Apart from replacing the northern balcony window with a simple timber one, much of the timber and brickwork is original. For the most part the *pati* has been commandeered and bricked up to provide accommodation.

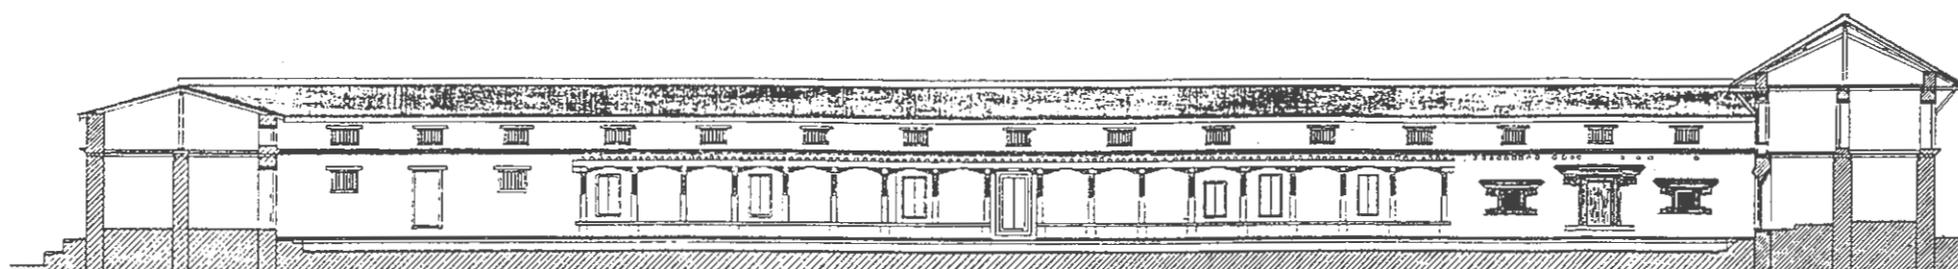
WEST WING

The 1934 earthquake caused extensive damage to the northern section of this *sattal*. As a result the upper floor was poorly reconstructed to form a half height space with rough brickwork, and primitive window details. A mono-pitched timber roof structure is covered with corrugated tin sheeting. This cramped and poorly lit upper level makes for intolerable living conditions with the added disadvantage of having to minimise habitable space with the provision of a corridor linking four separate living quarters to corner staircases. There remain two sections of original construction in the north corner at ground floor level as well as the central section of the *pati*, both of which have been bricked up and occupied by individual families. The southern section of the *sattal* was reconstructed at the same time as the upper floor level using primitive door and window details.

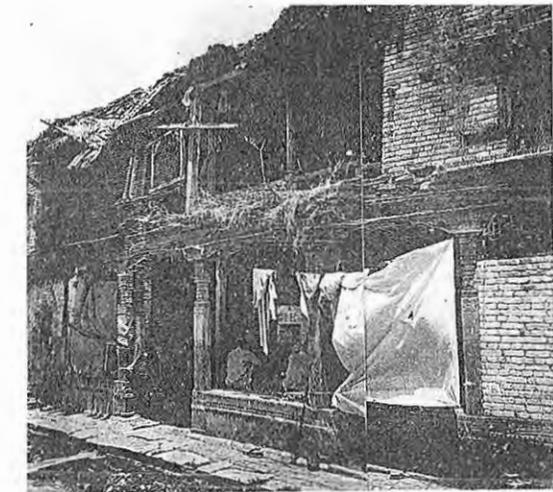
Fig. 41. The poor condition of the East Wing.

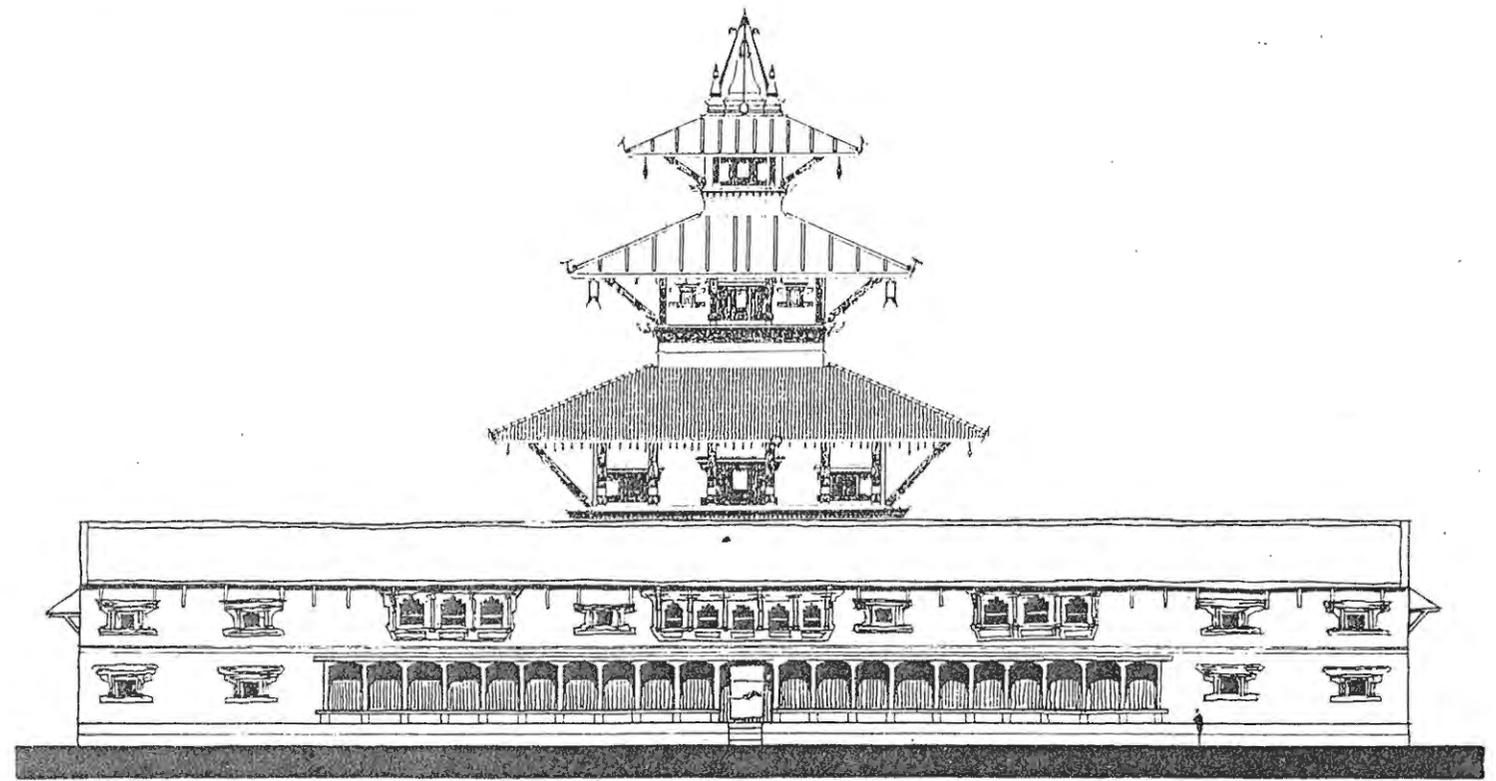
Fig. 43. Sketch Proposal for South Elevation following restoration.

Due to the exigencies of time and the 1934 earthquake there remains little evidence to suggest how this facade originally looked. The upper floor has been changed beyond recognition and the poorly built additions do little to provide inspiration as to the original form of what must have been a striking facade. The dramatic approach to the temple uphill from the river makes it important to re-create the original concept of the facade as it is now used as the principle entrance. Using the existing column bays forming the original external *patis* as a starting point, Fig. 43 shows a sketch proposal of what it might have looked like as a guideline of how it could be rebuilt.

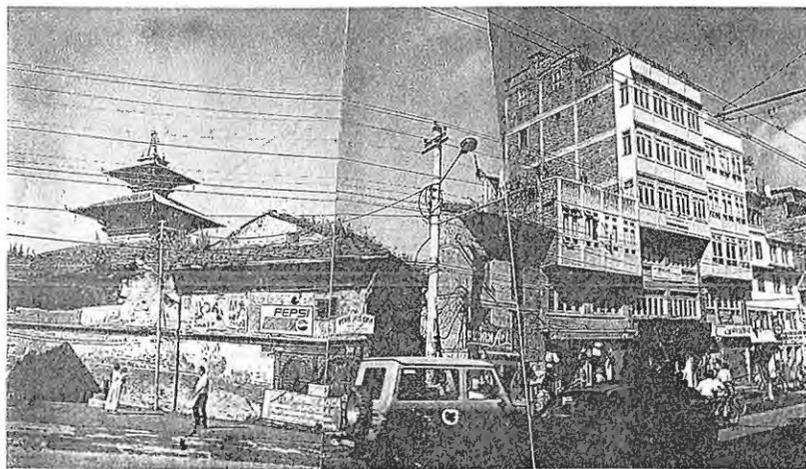
The external north facade was perhaps at the time of its original foundation an imposing elevation which gave onto the principle roadway and provided the main access to the temple complex. The heavy ground floor arches are indicative of the importance of the elevation and beneath the arches were no doubt easily accessible *patis* for pilgrims and travellers. The large doorways providing access to the courtyard would have been closed at night. Today, however, the scene looks very different with a modern seven storey block only 3 metres away. These buildings tower over the main entrance, denying it daylight or space. In recognition of the present condition of this former main entrance, it is recommended therefore to repair and consolidate only the present brick and timber structure without replacing the traditional window and door details (See Fig. 42).

Fig. 42. View of Tripureswar Temple Complex from Tripureswar Marg showing modern encroachment.

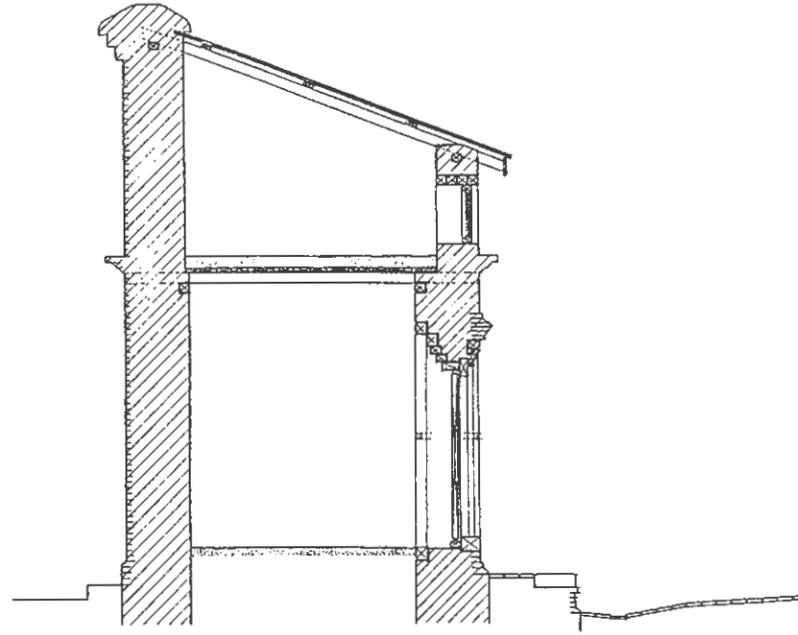
Fig. 45. Existing *sattal* Section through the West Wing; showing lack of space in Upper levels following inadequate reconstruction after the 1934 Earthquake.

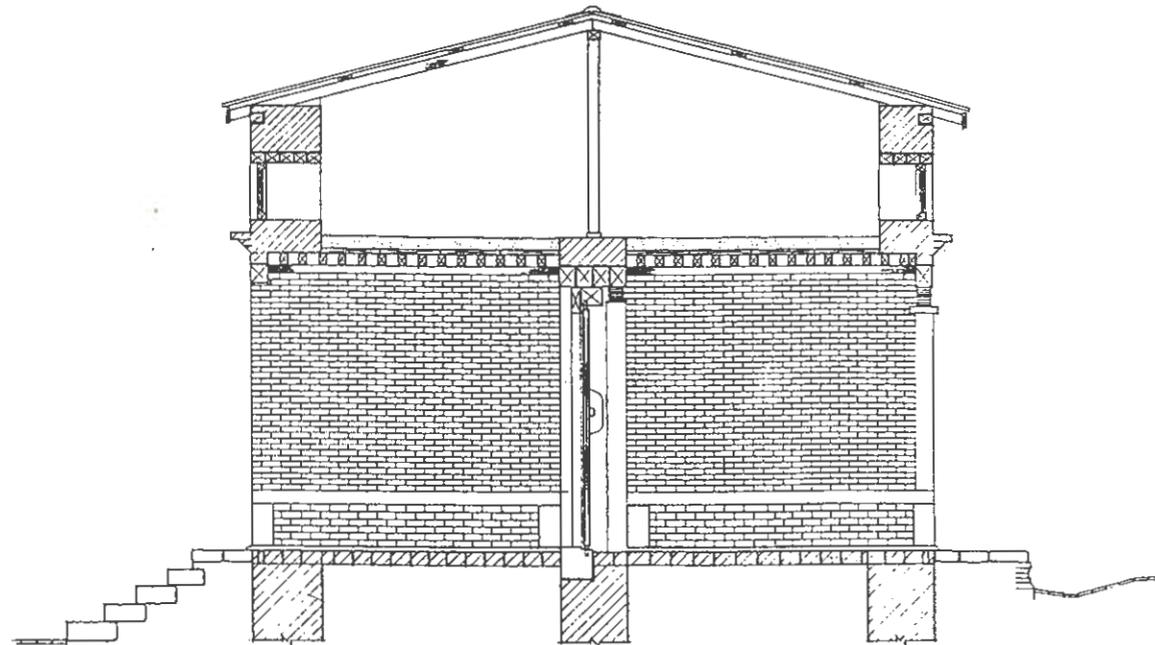
Fig. 46. Existing *sattal* Section through the South Wing; following inadequate reconstruction after the 1934 Earthquake.

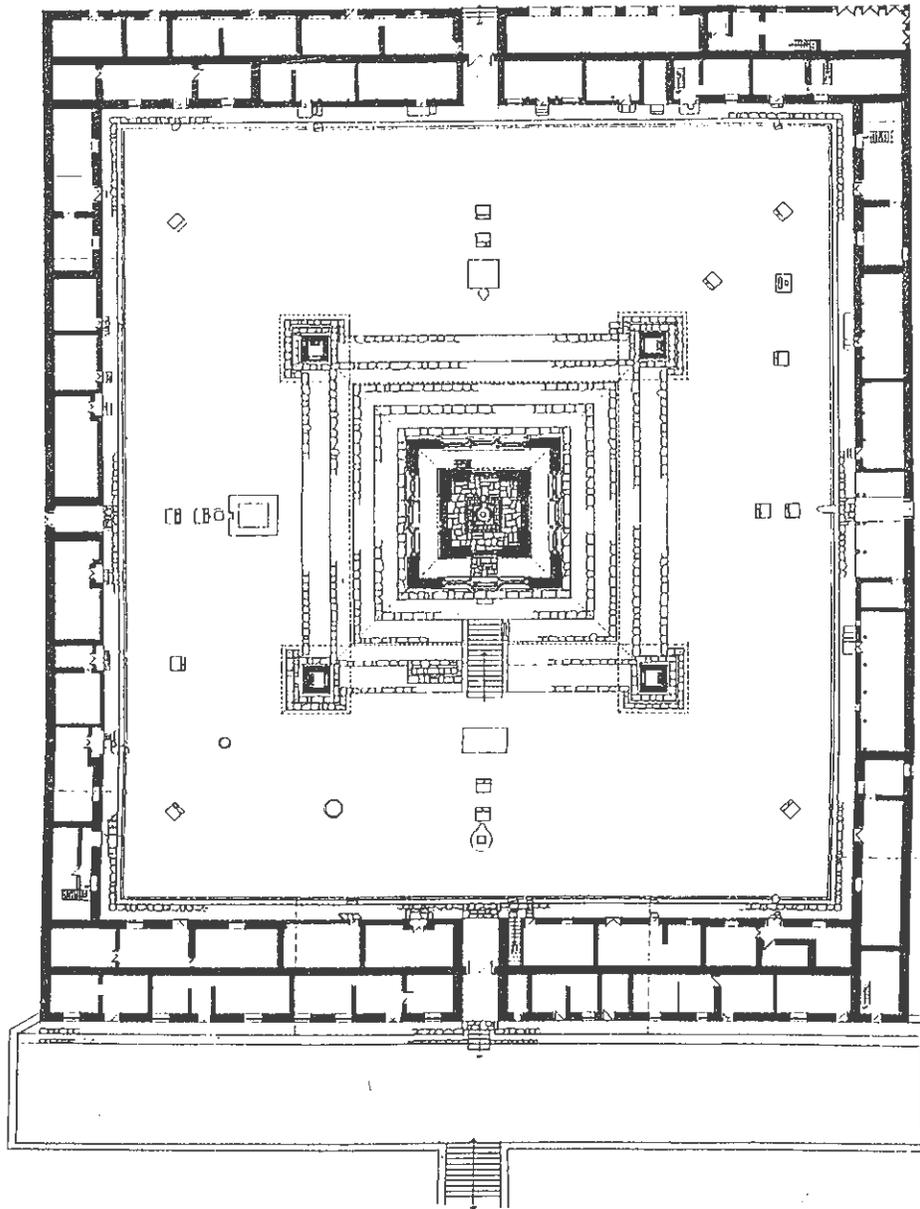
Fig. 49. Existing Ground Floor Plan; showing encroachment of the once open, public *pati* spaces.

Two hundred and ten people live in the *sattal* and the existing floor plans show the exceedingly cramped living space available to each family. Under present conditions the average space available per person amounts to just over four square metres. Almost all of the former public spaces used for communal activities have been commandeered by the present occupants by creating makeshift walls of brick or polythene sheeting to block the openings between the carved wooden columns.

The living conditions at present in the *sattal* are appalling. Most of the occupants complain of dampness on the ground floors, rainwater penetration through the roofs; infestation of vermin and a lack of any basic services. All amenities are located outside the compound but the water supply is insufficient and the only toilet facilities are poorly maintained. The stormwater and kitchen water drainage is persistently blocked, causing the retention of stagnant water in the courtyard.

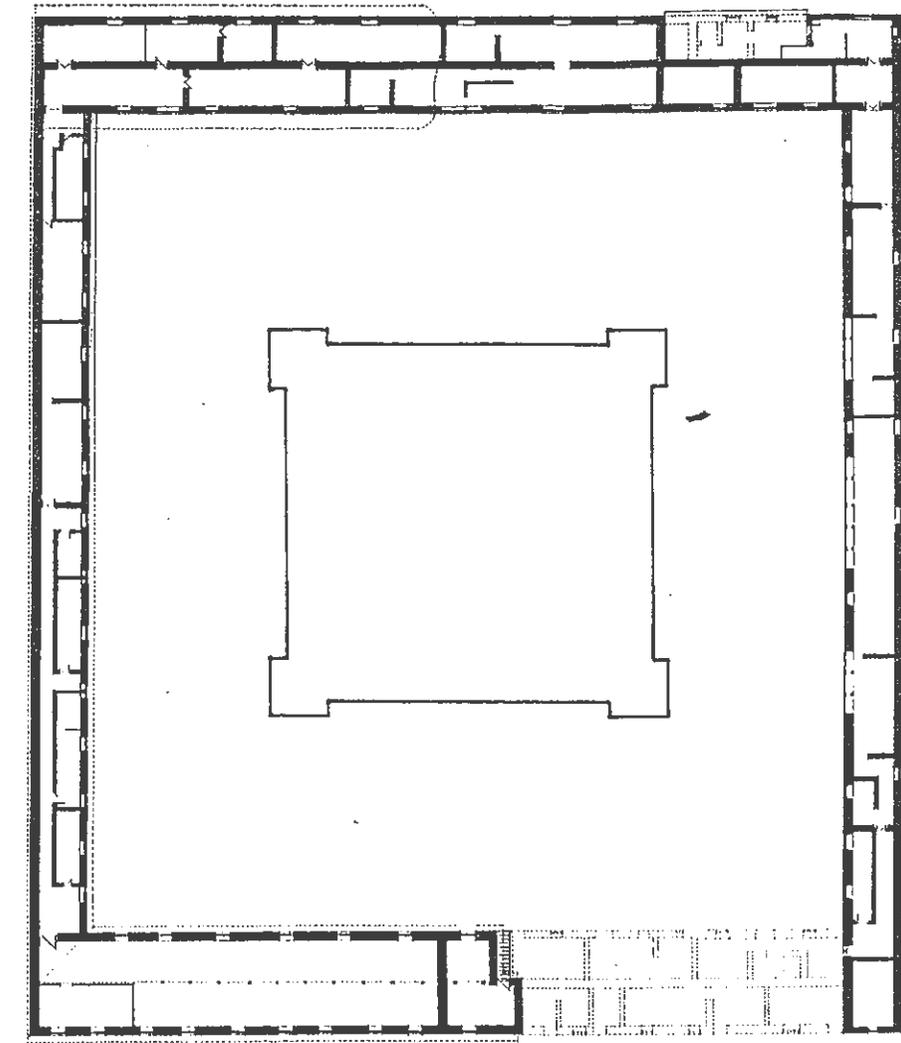
Accommodation on the upper level is limited by the partial collapse of the South Wing and the deteriorating conditions and poor reconstruction of the remaining wings.

Fig. 50. Existing First Floor Plan; much of this level is at present unusable, due to roof damage, lack of space and instability of the structure.
