THE TEMPLE

TRIPURESHWAR MAHADEV MANDIR

THE SATTAL

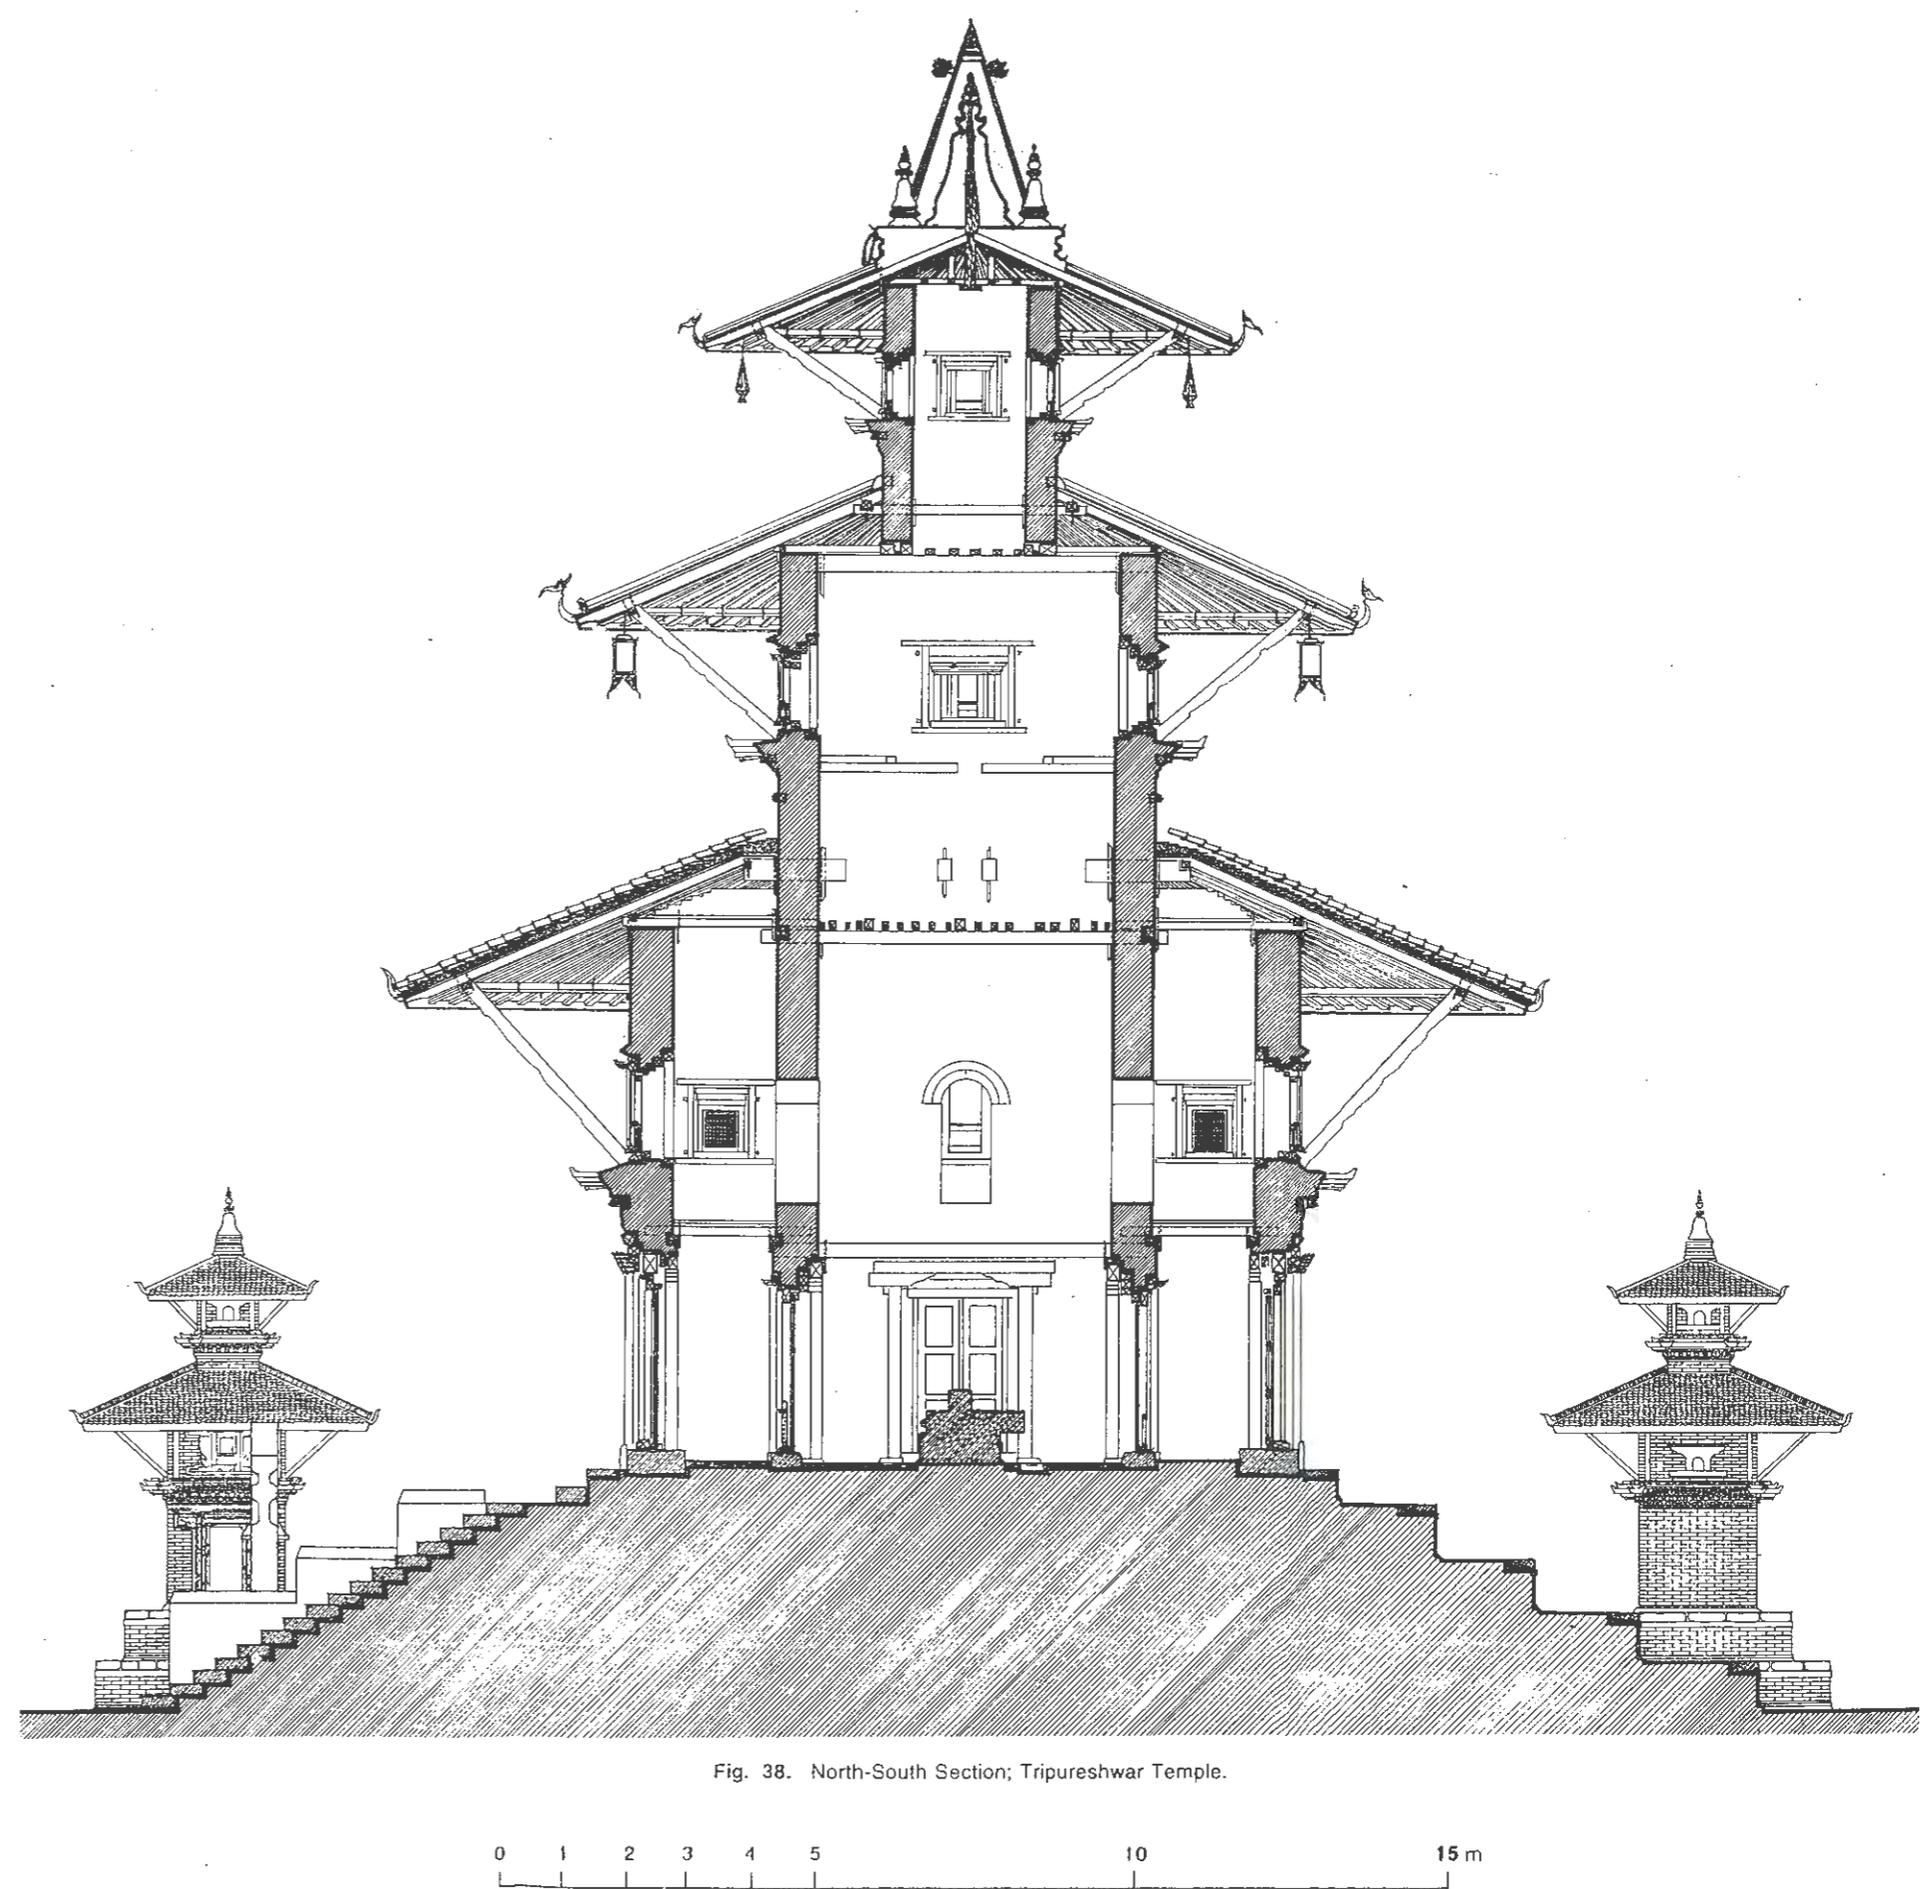
Fig. 38. North-South Section; Tripureswar Temple.

The roofs are of traditional timber construction supported off external walls and a central brick core which in turn carries the upper two roofs. The lower roof is covered with the traditional *Jhingati* tile set in a thick bed of clay, the upper two roofs are covered with copper sheeting (and originally gilded). The external walls of the temple structure are constructed with the special *do appa* (traditional wedge shaped bricks) that hide the mortar joints, several of which have been replaced with simple handmade bricks. The carved *Tunasi* to all the roofs and the 28 elaborately carved windows and four carved triple door are, except where damaged by water penetration, in reasonably good condition.

A complete and thorough structural survey of the temple is not possible without scaffolding. From initial investigations it seems that, in general, the upper two metal roof structures are in reasonable condition. However it is anticipated that many of the *musi* (rafters) will have rotted under the metal covering and will need to be replaced. It is recommended therefore to remove the roof covering, the *phalek* (timber boarding) and to check the condition of the timber rafters and their fixings. When the structural timbers, such as the supporting beams carrying the uppermost roof structure are exposed, they should also be thoroughly checked for structural integrity. It is likely that the boarding to both the roofs will require almost complete renewal.

The lowest roof covered with *jhingati* tiles is, through lack of maintenance requiring a total overhaul. It is recommended that the structural integrity of the wall plates is carefully checked and if necessary they should be replaced with a carefully designed concrete ring beam which can be hidden within the present structure. The old timbers should be treated against infestation in situ.

New timbers in all the roofs and other timber structural elements should be chemically treated against wood boring insects and fungal attacks. When replacing the clay bed for the tiles, the clay should be treated with a special herbicide to prevent the growth of vegetation and the tiles should be dipped in a silicone preparation to prevent undue rainwater absorption.

The brickwork requires some careful conservation and replacement. It is recommended that a careful assessment is made of the replacement requirements and new bricks are specially ordered from the kiln to replace them.

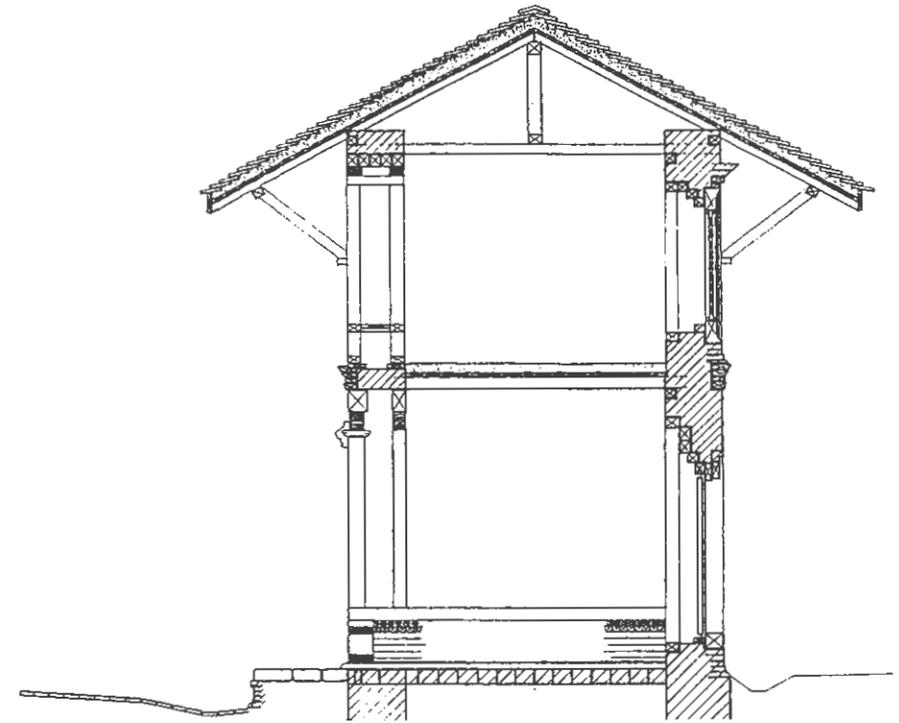
Fig. 47. Existing *sattal* Section through the East Wing; showing the traditional, single bay construction with a large upper level space.

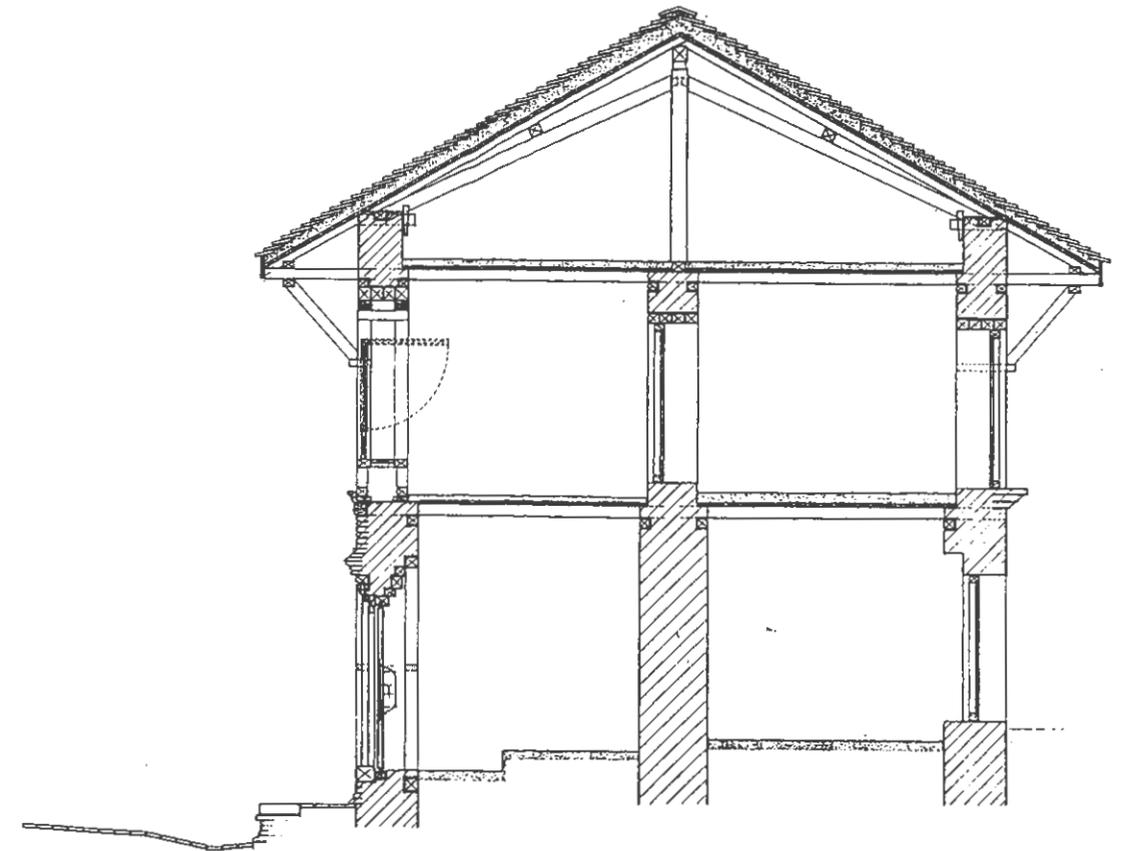
Fig. 48. Existing *sattal* Section through the North Wing; showing the traditional, double bay construction with enclosed space facing the courtyard at ground level.
